Manhole Inspection Summary

Manhole # S03EE2011MH

Location Address: **6201 HEATHERIDGE DR** Cross Street: **RED CEDAR PL**

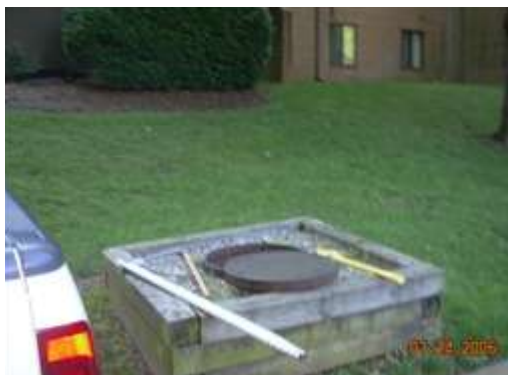
Location View

Comments **Manhole is in a pebble box about 1.5 ft above grade.**

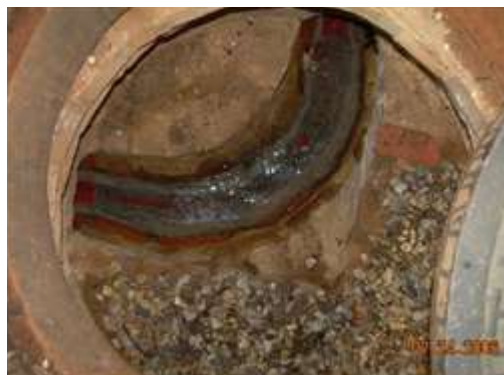
Top View

Frame Offset: **2** (in.) Condition: ☐ Sound ☐ Cracked ☒ **Leaks**

Bench ☒ Exists Material: **Brick** ☐ Parged ☒ **Debris** (not Condition related)
Condition: ☒ Sound ☐ Cracked ☐ Root Intrusion ☐ Deteriorated ☐ Leaks ☐ Debris

Frame leaks. Frame offset. Bench debris.

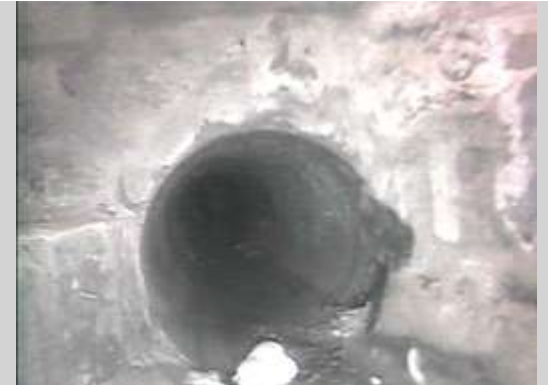
8 in. Circular Gravity Sewer Pipe Out @ 12 O'Clock

Infiltration: **Evidence** Pipe Seal Cond: **Unknown**

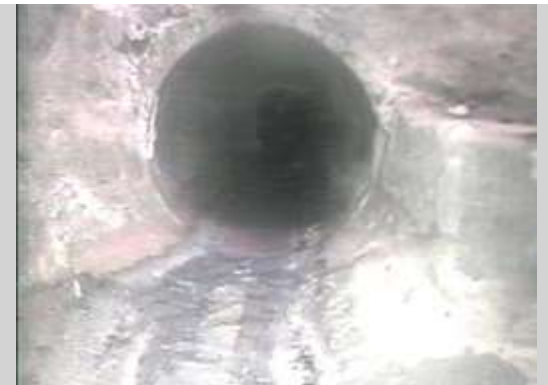
8 in. Circular Gravity Sewer Pipe In @ 9 O'Clock

Infiltration: **Evidence** Pipe Seal Cond: **Unknown**
